## Averted Piping Failure—Earth Dam on Permeable Foundation

Scott Newhouse

*Bechtel Power Corporation, Frederick, MD*

## AVERTED PIPING FAILURE—EARTH DAM ON PERMEABLE FOUNDATION

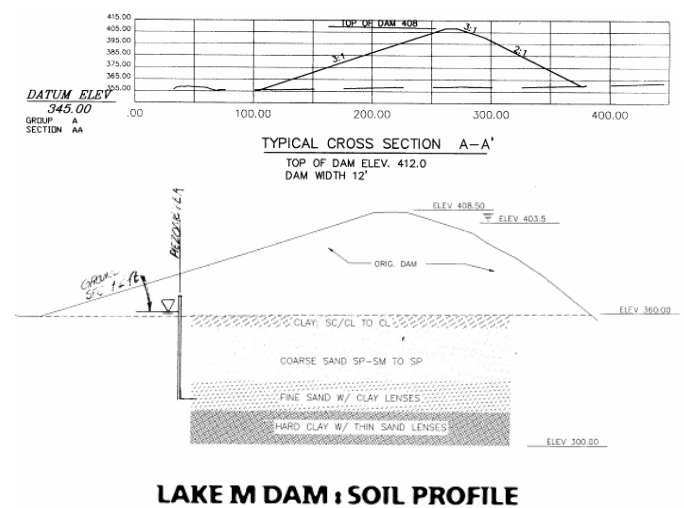
Fig. 1. Lake Mailande Dam—Typical Section and Soil Profile

Lake Mailande Dam was originally built in 1994 as a homogeneous embankment (without filter/drain protection). Figure 1 depicts the typical cross section, taken from the construction plans, and depicts the soil profile beneath the dam. As shown in Fig. 1, design did not include seepage control—neither a cutoff in the foundation nor an internal filter/drain. The construction plans did not address foundation treatment at all, leading to extensive questions during construction regarding soft soils, high groundwater, and seepage control. The dam is about 55 ft high and 1,800 ft crest length, with 337,000 cu yd of embankment fill. The dam has sparse rural development downstream that includes houses in its flood path and a county road at the toe. Accordingly, it is classified high hazard. Lake Mailande is privately owned, used solely for recreation.

After construction commenced, further exploration was performed to establish the soil conditions depicted in Fig. 1. Exploration shows:

- Significant layers of sand in the foundation
- Significant coefficient of hydraulic conductivity ( $k$ ), of maximum  $10^{-3}$  cm/s
- Artesian water pressure rising to near 2 ft above ground surface

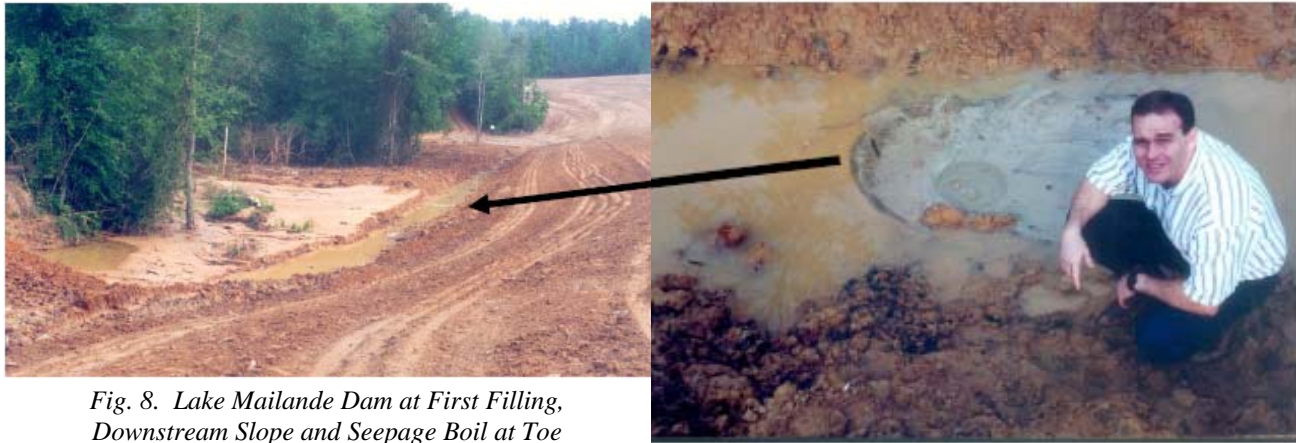
Fig. 8. Lake Mailande Dam at First Filling, Downstream Slope and Seepage Boil at Toe

At the time the conditions depicted in Fig. 8 formed, the design engineer interpreted the boil as a harmless spring, and interpreted the piezometer level as an effect of consolidation due to pressure on the ground from the embankment. However, facts did not support these interpretations:

- The seepage boil clearly had a cone of deposition showing fine soil being eroded.
- The piezometer level showed steady increase with increasing lake elevation, not with increasing embankment height. Excess pore pressure from consolidation would correlate with the pressure applied by increasing height of embankment fill and would show dissipation over time instead of a steady increase.

The seepage boil was covered with a fabric filter and stone ballast to control erosion. State officials directed that the lake be lowered to a safe level until the dam was renovated. Lowering the lake level and covering the boils averted dam failure by erosion/piping through the foundation. The initial prediction that a homogeneous dam could be built on the permeable foundation at this site was obviously wrong.

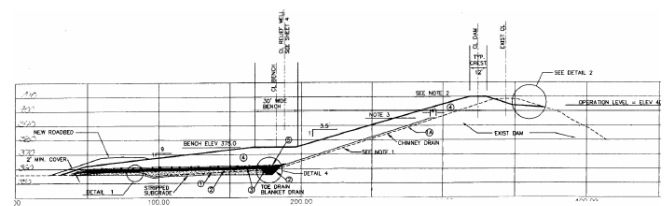
Fig. 9. Renovated Dam Cross Section

performance shows that predictions that the dam could be renovated without a cutoff were accurate.

Figure 9 shows the typical cross section engineers developed to renovate the dam and ensure downstream slope stability and safety against piping. Engineers had difficulty in evaluating the need for a foundation seepage cutoff. As shown in Fig. 9, engineers decided that water pressure and hydraulic gradient could be controlled with drainage works, and that a cutoff was unnecessary. Modifications to the dam included a chimney drain, toe and blanket drains, and relief wells drilled into the artesian zone. The renovated dam was placed in service in 1997 and has performed well. The renovated dam's

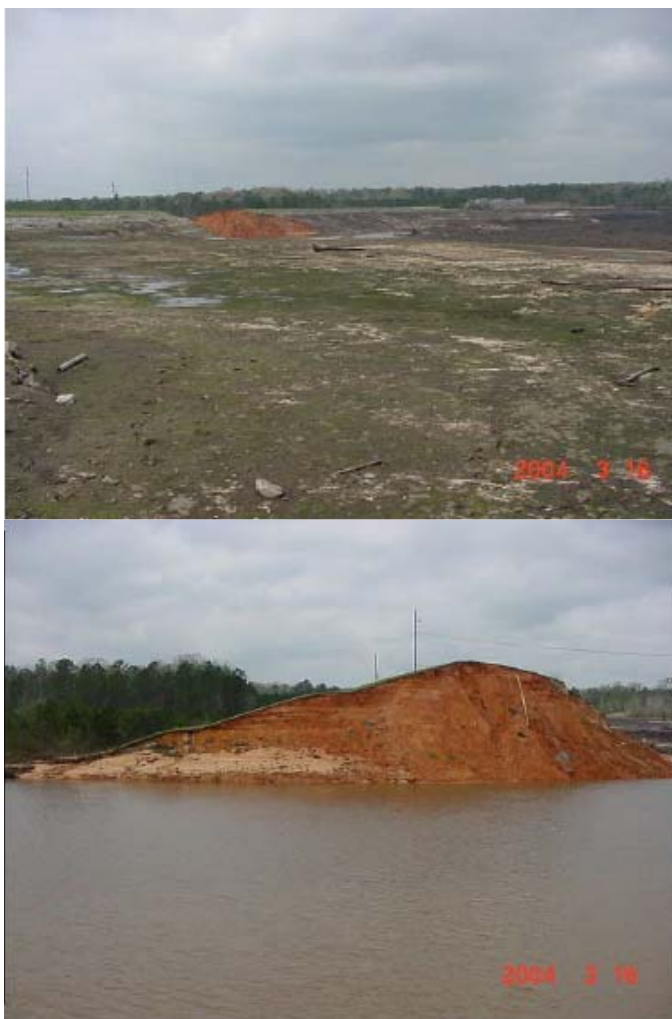
Fig. 10. Big Bay Lake Dam Breach, Lamar County, Mississippi  
(Photos from National Weather Service, Jackson, Miss.)

**Big Bay Lake Dam.** Big Bay Lake Dam (see Fig. 10), near Purvis, Miss., was built in 1991. It experienced a sunny day failure unexpectedly in 2004. The dam is a 57 ft tall earth embankment; the impounded reservoir was about 1,100 ac (ASDSO, 2005). The dam was evidently built with a blanket drain, but without a foundation seepage cutoff. The failure mechanism is theorized to be piping through the foundation.

Not enough information on the Big Bay Lake Dam has been published to allow comparison to Lake Mailande. Consequently, one cannot say whether foundation soils in this dam were more or less permeable than at Lake Mailande.

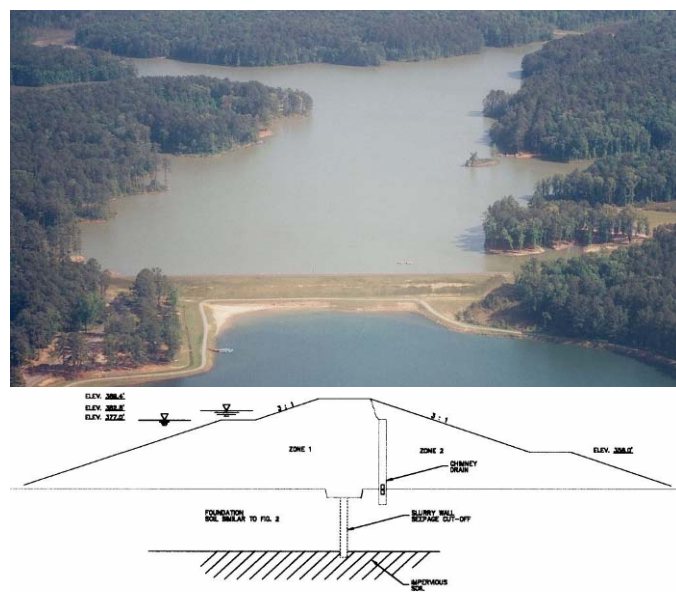
Fig. 11. Bonita Lake Dam Photo and Cross Section

**Bonita Lake Dam.** Bonita Lake Dam (see Fig. 11) is within 4 mi of Lake Mailande, with similar size of dam and reservoir. It was designed and built by NRCS for municipal water supply and flood control purposes. This dam is about 60 ft high and 1,500 ft crest length, with 380,000 cu yd of embankment fill. Soil conditions here are similar to Lake Mailande, but there is less thickness of alluvial sand in the foundation. Artesian groundwater pressure was not encountered at Bonita Lake.

Bonita Lake Dam was built with the elements that the BuRec design manual calls for—positive seepage cutoff and internal drain, although the drain here is a vertical chimney and not a horizontal blanket. The Bonita Lake Dam has performed without problems related to seepage.
